DREDGING OPERATIONS TECHNICAL  
SUPPORT PROGRAM

MISCELLANEOUS PAPER D-92-1

AN ENVIRONMENTAL ASSESSMENT  
OF THE EFFECTS OF OPEN-WATER DISPOSAL  
OF MAINTENANCE DREDGED MATERIAL  
ON BENTHIC RESOURCES  
IN MOBILE BAY, ALABAMA

July 1992

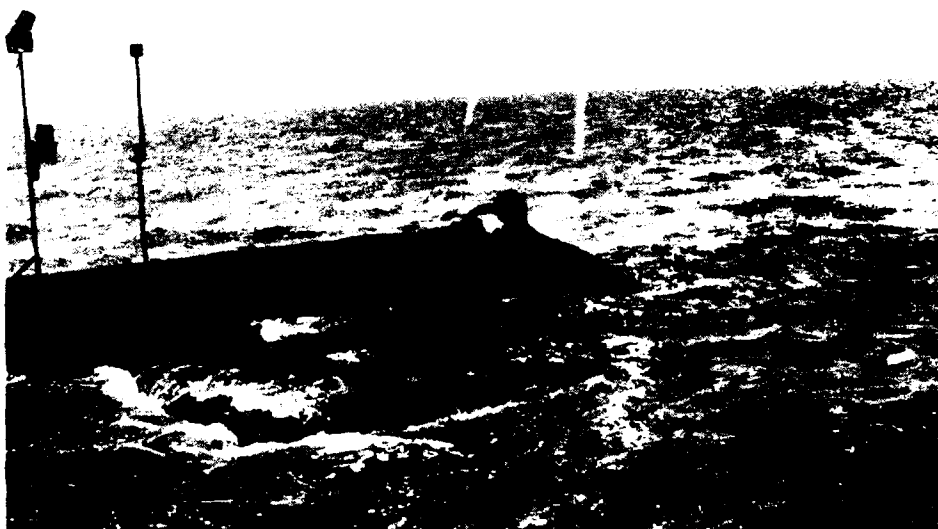
Figure 3. Configuration of pipeline terminus in place during the study

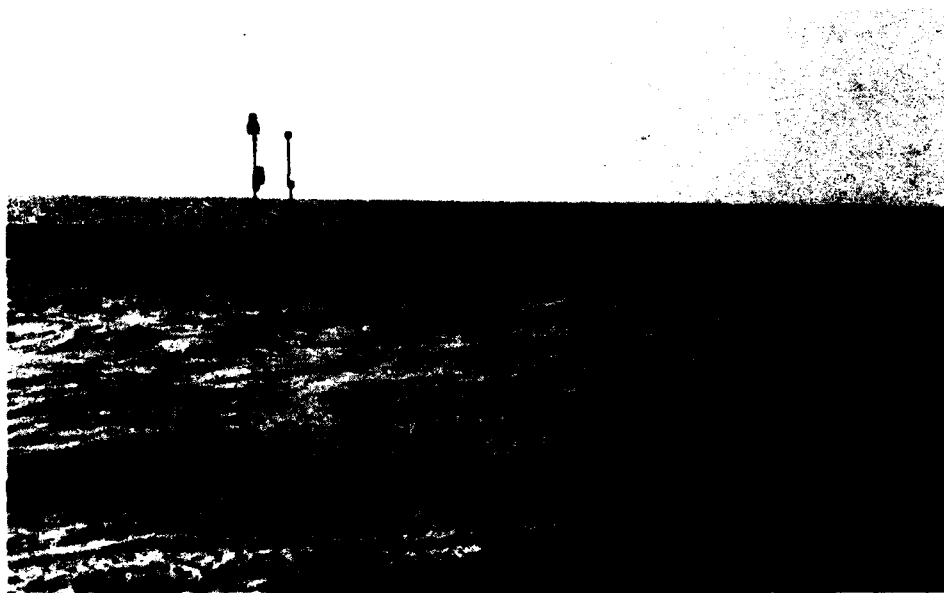
Figure D3. Downward-angled discharge used in 4 June and 16-17 June 1988 surveys

The discharge line ended with a downward angled (approximately 30 deg from horizontal) pipe section (Figure D3). The discharge jet exited the pipe about 3 ft below the water surface in the downward direction. The captain of the dredge reported the pipeline velocity at about 21 fps. The inside diameter of the discharge line was 25 in., resulting in a discharge
